HIGHWAY ACCIDENT REPORT

MULTIPLE VEHICLE COLLISION WITH FIRE DURING FOG
NEAR MILEPOST 118 ON INTERSTATE 40
MENIFEE, ARKANSAS, ON JANUARY 9, 1995

SPECIAL INVESTIGATION OF COLLISION WARNING TECHNOLOGY

**Adopted: December 4, 1995
Notation 6530A**

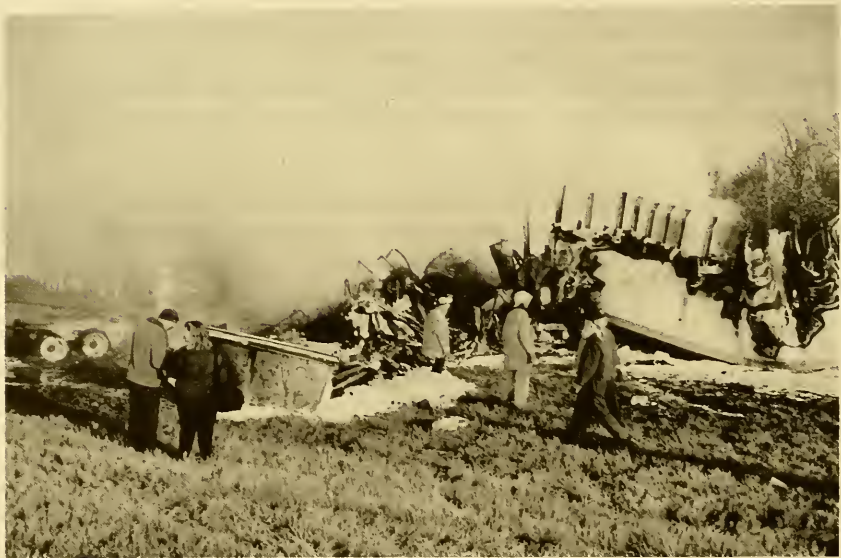
The rear of the fifth combination unit had heavy impact and fire damage. The sixth, seventh, and eighth combinations and the van were destroyed by impact and fire. (See figure 1.)

Figure 1. -- Remains of vehicles after impact and fire.

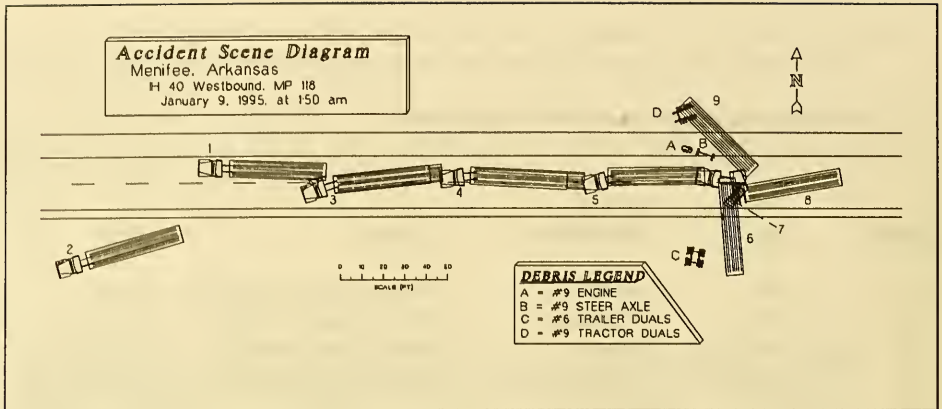
Figure 2. -- Postaccident scene diagram showing position of vehicles.

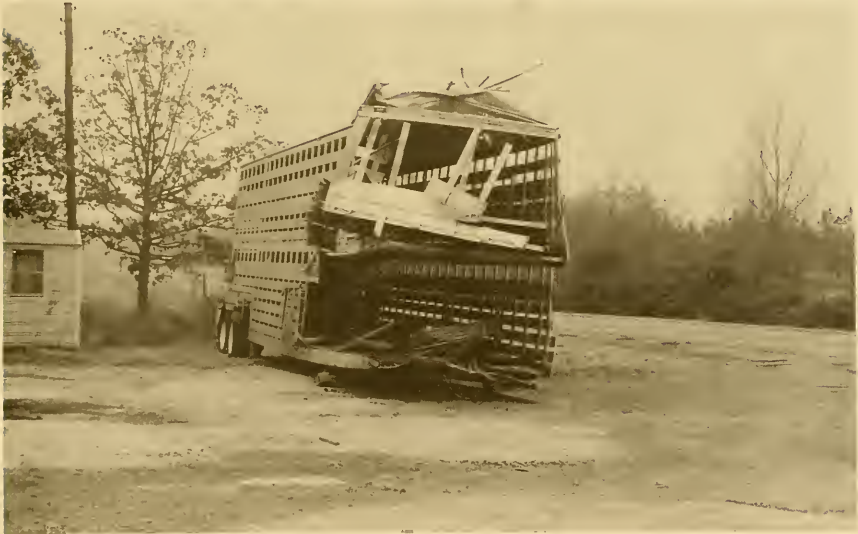
The lead combination was struck twice, sustaining extensive damage to the rear of its trailer. The second and third combinations both struck the rear of the first combination, and the fourth combination struck the rear of the third combination. The fifth combination braked to a stop and was struck from behind by the sixth combination. The van either struck the rear of the sixth combination or was pushed into it when the seventh combination collided with the rear of the van. The eighth combination struck the side of the seventh combination, the rear of the van, and the sixth combination, and a fire ensued.

Photograph 1. -- Combination 1 trailer (view from rear toward front).

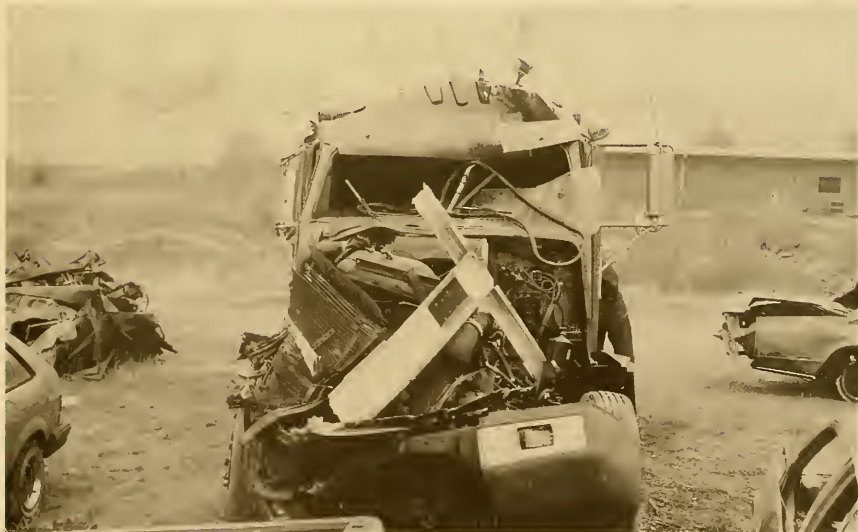
Vehicle 2 -- Vehicle 2 was a 1992 Freightliner tractor in combination with a 1987 Barrett, 48-foot split level livestock semitrailer that was loaded with cattle. The combination weighed 78,100 pounds. Thirty-one inches of contact damage was on the tractor front bumper, grill, and fenders, extending from the right side toward the center. The front structure was shifted 11 inches to the right, and the right side wheelbase was reduced 18 inches. The front structure of the semitrailer had substantial damage. (See photographs 2 and 3 in appendix B.)

Photograph 2. -- Combination 2 tractor.

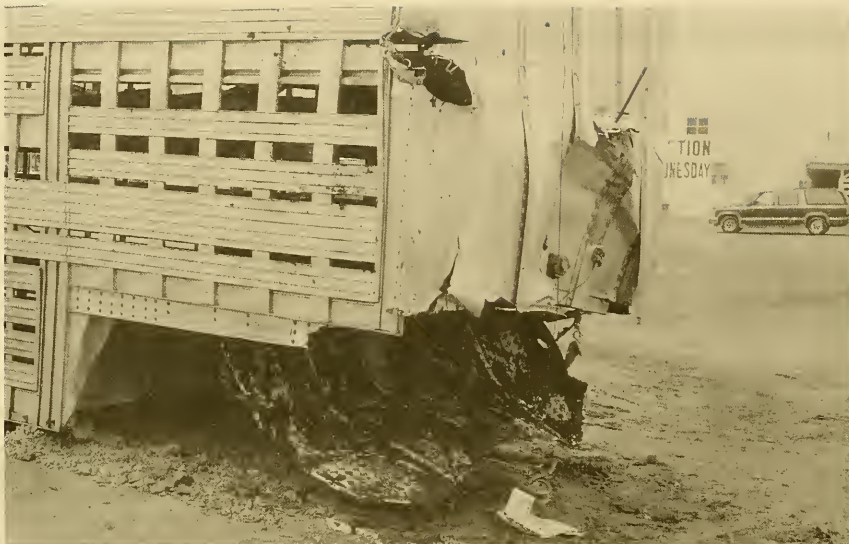
Photograph 3. -- Combination 2 trailer (front damage).

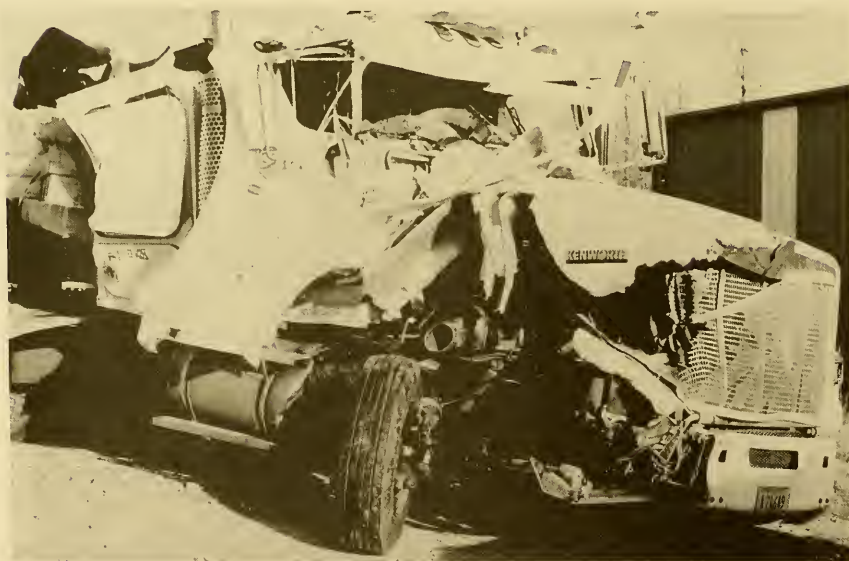
Vehicle 3 -- Vehicle 3 was a 1995 Kenworth truck tractor in combination with a 1990 Fruehauf, 48-foot flatbed semitrailer that was loaded with railroad ties. The estimated weight of the combination was 79,000 pounds. The right front of the tractor had 34 inches of contact damage, beginning at the right edge and extending in toward the center. The right front wheel was turned outward 75 degrees; the right front airbrake hose was separated from its frame connection. The forward headwall of the right side fuel tank was punctured, allowing fuel to leak out. The rear of the semitrailer had 48 inches of moderate contact damage that extended from the left side toward the center. The cargo of wood ties moved forward 90 inches at impact, and the shifting cargo pushed down and fractured the front headerboard.⁴ The rear of the sleeper cab was pushed inward approximately 24 inches. (See photographs 4, 5, and 6 in appendix B.)

Photograph 4. -- Combination 3 tractor.

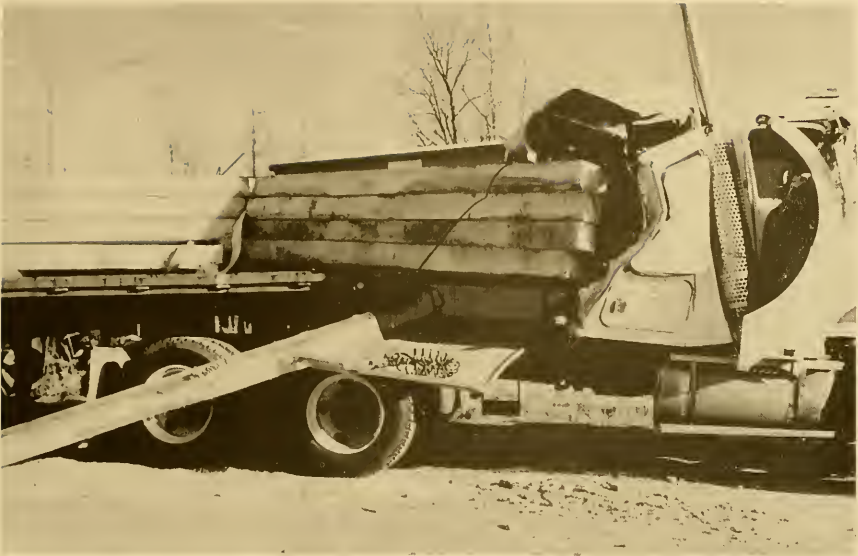
Photograph 5. -- Combination 3 (right side and rear tractor cab damage with headerboard deformation).

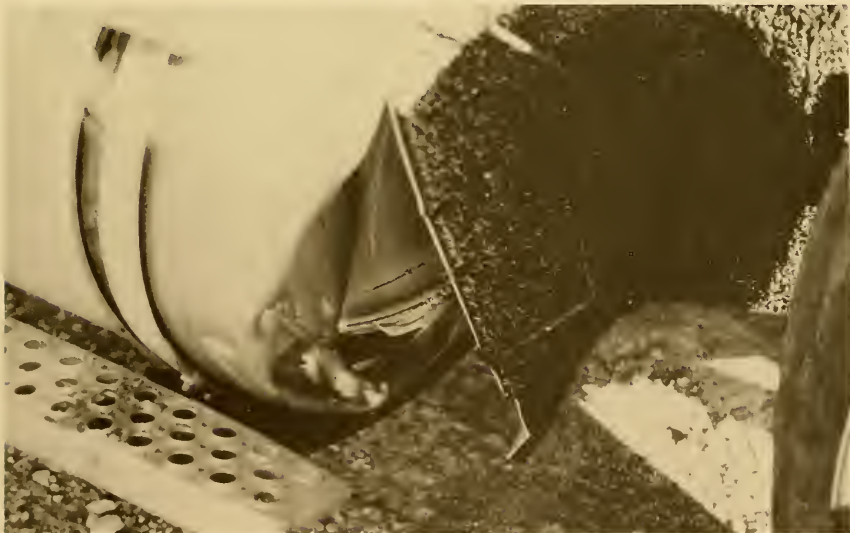
Photograph 6. -- Tractor 3 (front fuel tank damage and puncture).

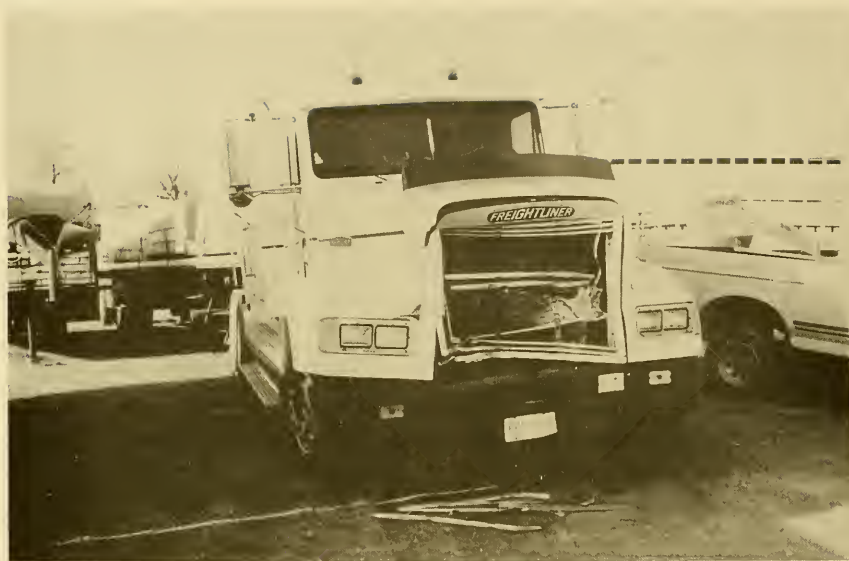
Vehicle 4 -- Vehicle 4 was a 1992 Freightliner tractor in combination with a 1994 Utility, 48-foot flatbed semitrailer loaded with wood railroad ties. The estimated weight of the combination was 80,000 pounds. The front of the tractor had radiator damage, and the semitrailer had 38 inches of contact damage on the left rear, extending from the left edge toward the center. Also, the headerboard on the front of the semitrailer was fractured similarly to the vehicle 3 semitrailer when its load shifted forward at impact. (See photographs 7 and 8 in appendix B.)

Photograph 7. -- Tractor 4.

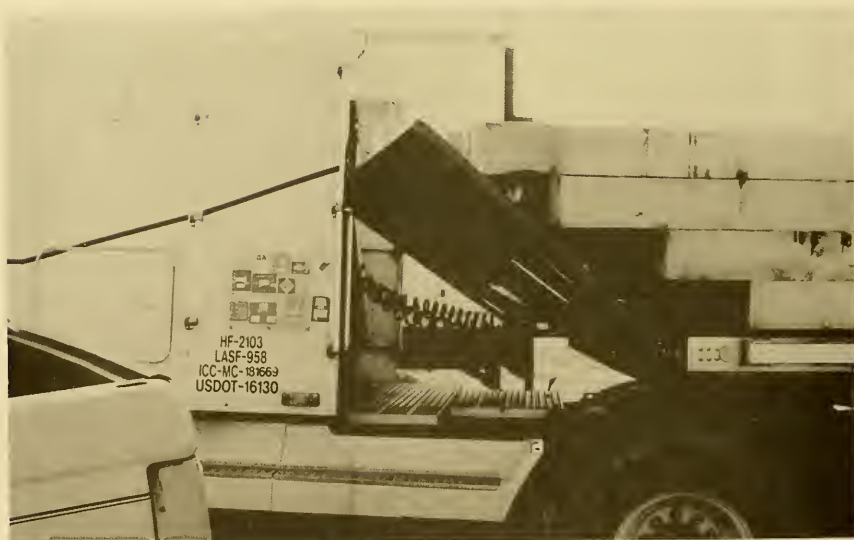
Photograph 8. -- Combination 4 (left side tractor/trailer with headerboard deformation).

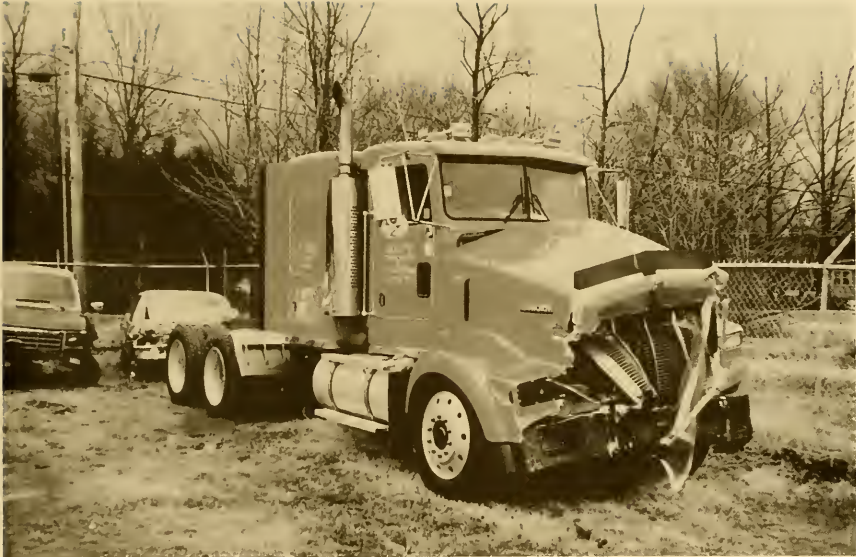
Vehicle 5 -- Vehicle 5 was a 1995 Kenworth truck tractor in combination with a 1984 Utility, 45-foot semitrailer loaded with scrap metal. The combination weighed 78,460 pounds. The tractor sustained substantial damage on its front, and the semitrailer had extensive rear impact and fire damage. The steel bed was pushed inward 11 inches, and the axles were destroyed by the postcrash fire. (See photographs 9 and 10 in appendix B.)

Photograph 9. -- Combination 5 tractor.

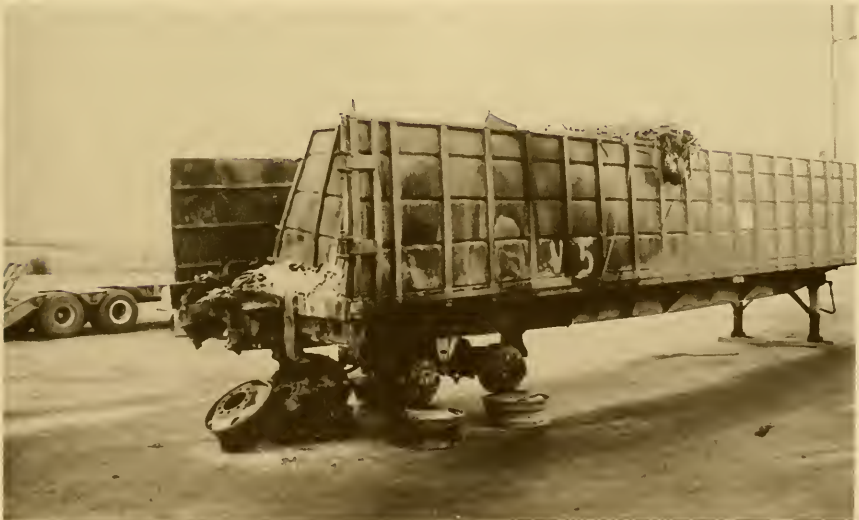
Photograph 10. -- Combination 5 trailer (rear impact and fire damage).

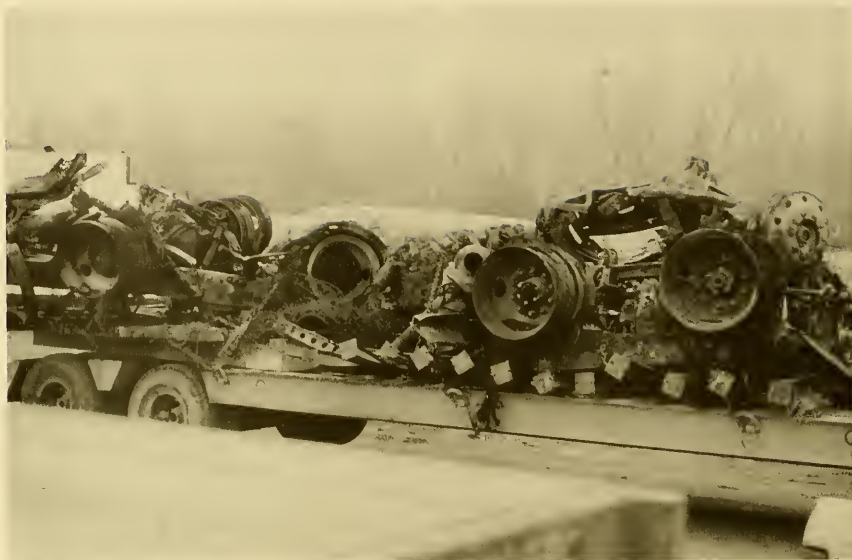
Photograph 11. -- Combination 6.

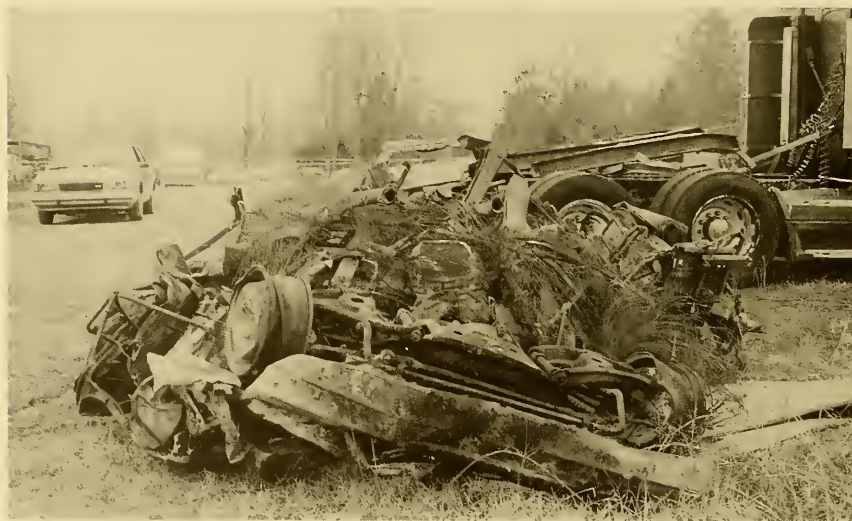
Photograph 12. -- Vehicle 7 (crushed van remains).

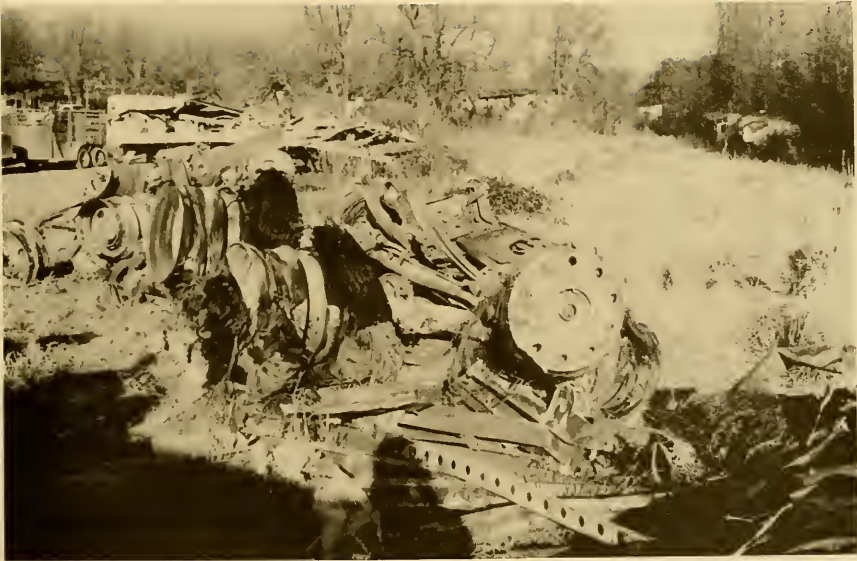
Photograph 13. -- Combinations 8 and 9 (remains).

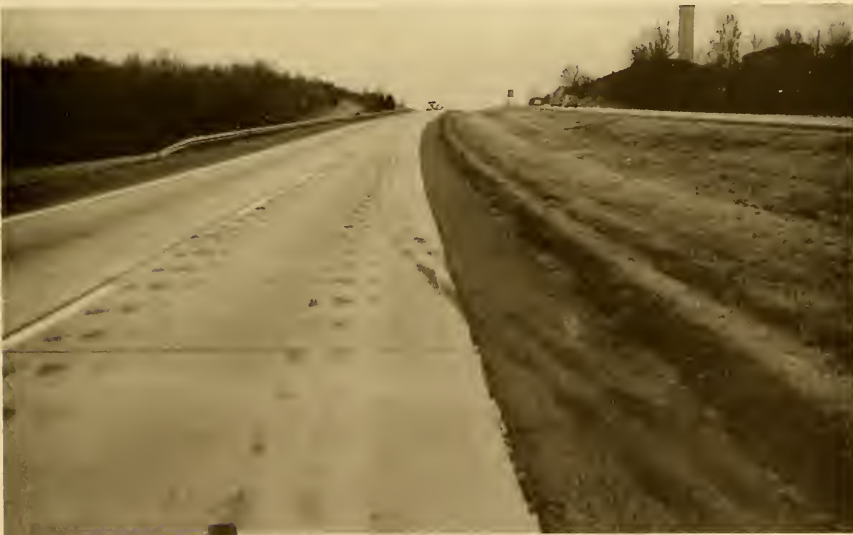
Photograph 14. -- Downgrade approaching accident site
(viewing back towards east).

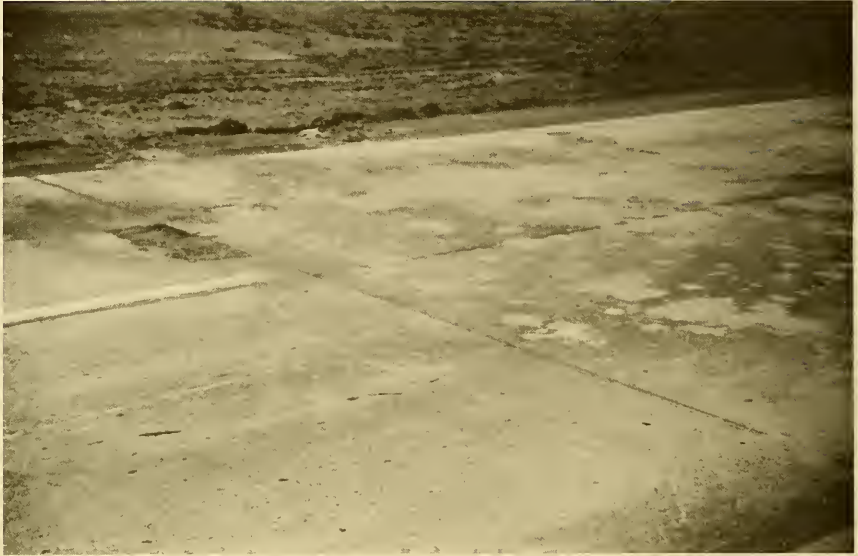
Postaccident Physical Evidence -- As a result of the collisions, the road surface was covered with fuel and debris. A large portion of the road surface, approximately 20 feet by 40 feet, was burned and scorched. (See photographs 15 and 16 in appendix B.) A significant amount of physical

Photograph 15. -- Accident site (road surface damage).

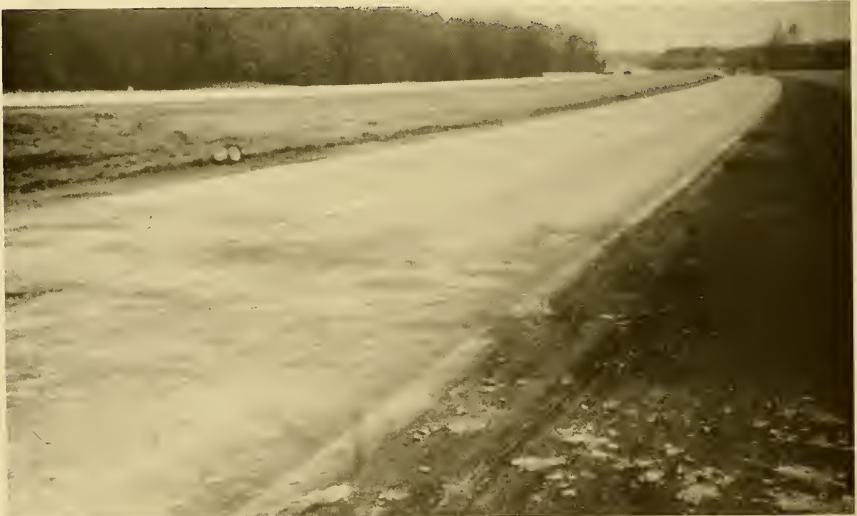
Photograph 16. -- Accident site (viewing toward west).
